XBOX 360 'RING OF DEATH' FIX

X-Clamp Replacement Fix

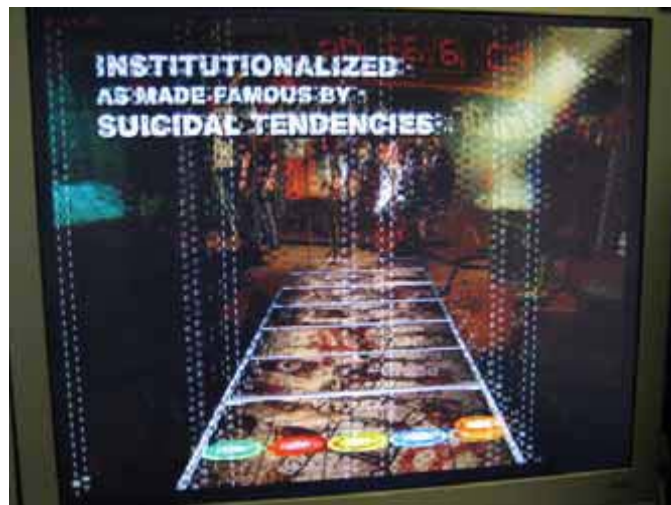
This happened to occur while i was playing Guitar Hero 2 (after whammy patch was applied, but I was getting 1 or 2 odd freezes like this before the patch).

As you can see, I was getting weird artefact issues with the image when it was freezing. There was also an awful sound coming out the speakers for about a second.

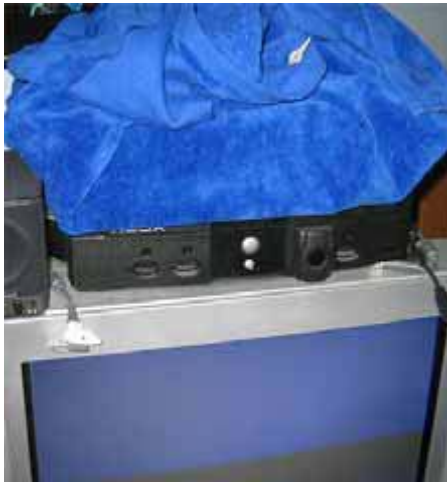
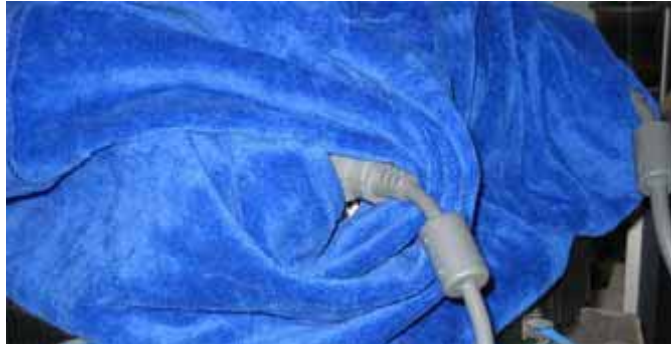
This method basically involves wrapping your Xbox 360 up in a towel to prevent any airflow from getting in, or out, of the Xbox 360. This in turn forces the Xbox to get really hot. You must leave the video plug attached, so that the Xbox does not auto shut off. I left it running for about 15 minutes. It got pretty warm...

(xbox360 is wrapped in towel above my original xbox). TV underneath showing no signal.

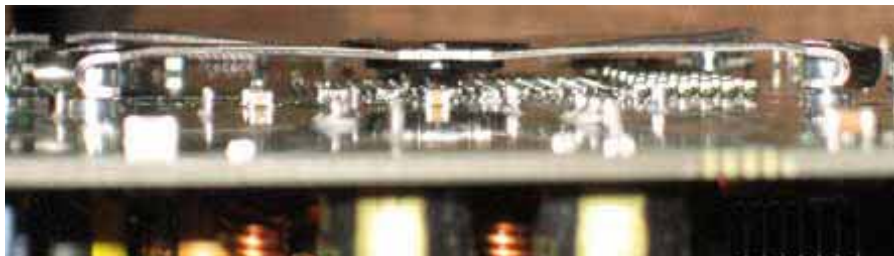
Here is a picture of the underside of the Xbox 360 motherboard, showing the X-Clamp. It's a bit of a pain to remove, but you basically just use a screwdriver, and wedge/force the end parts off the bolt part going through the board. The first couple may be pretty stiff, so you may will need a bit of force.

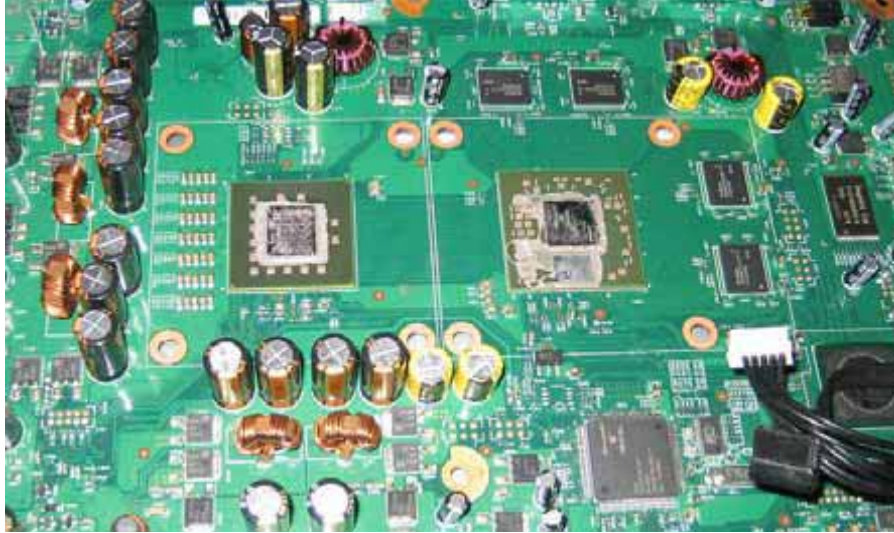
Once the X-Clamps are removed, the heatsinks will just come off. Just lift the heatsinks off the cpu/gpu.

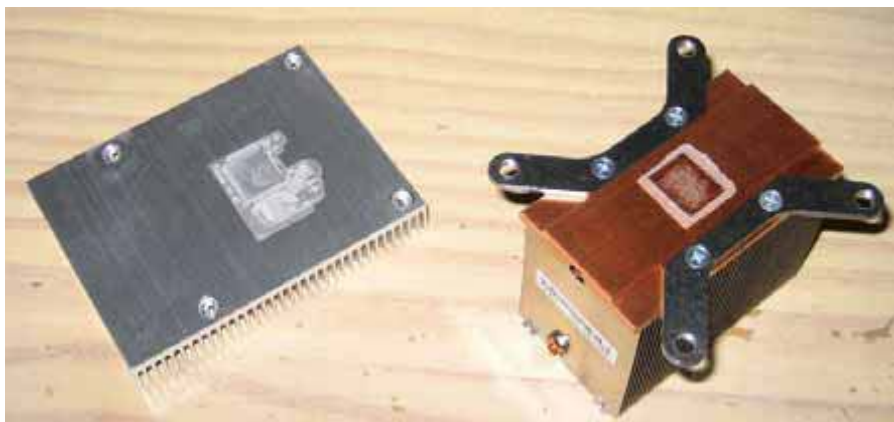
There is a fair bit of thick thermal compound on both the cpu/gpu and heatsinks. This needs to be removed.

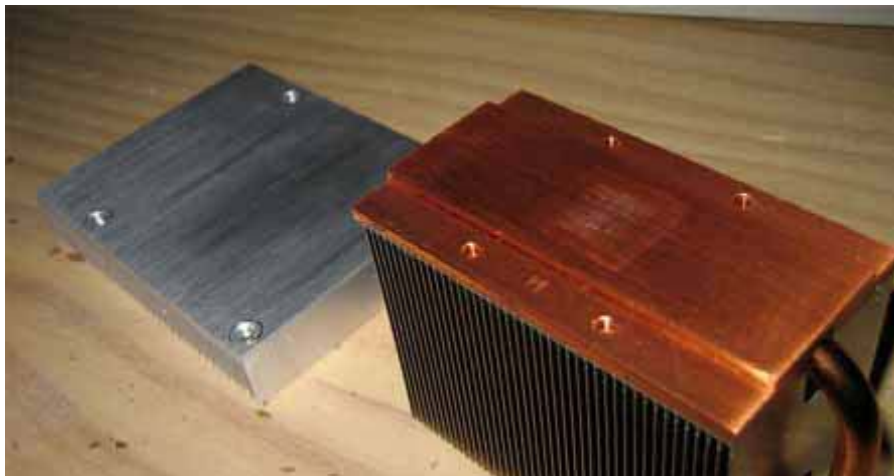
After a quick clean, they should look similar to the next picture. Use ArctiClean 1 to get a good clean surface. This next picture is after using a credit card to remove excess paste, but before using ArctiClean 1.

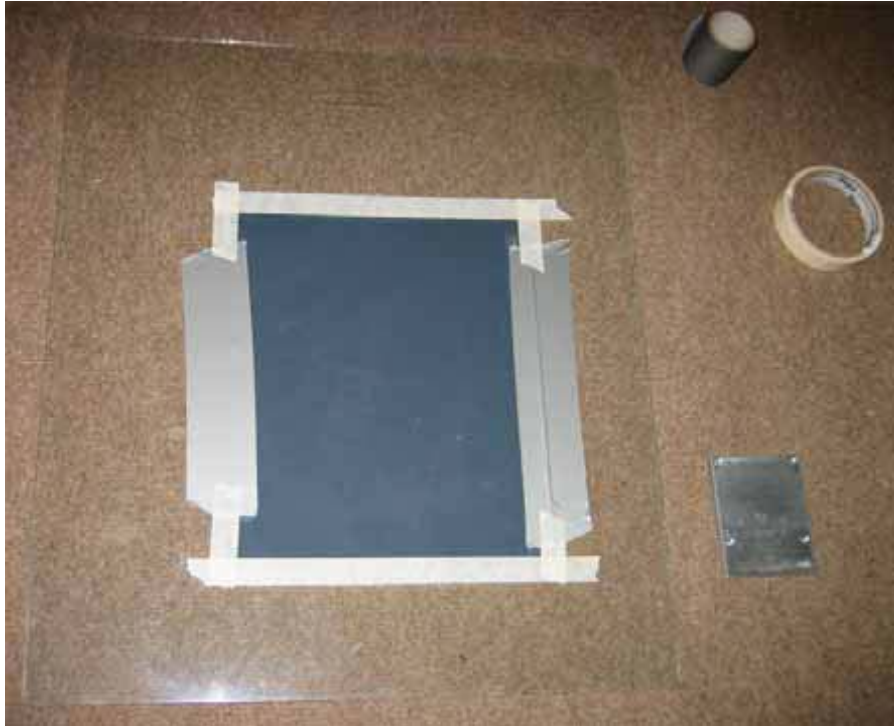
Basically it involves wet sanding the heatsinks on a flat surface (glass, or similarly flat surface), to remove any possible rough grooves in the heatsink. I started with 600 grit, and moved onto 800, and finished with 1200 grit. You could go to 2000 grit if you want.

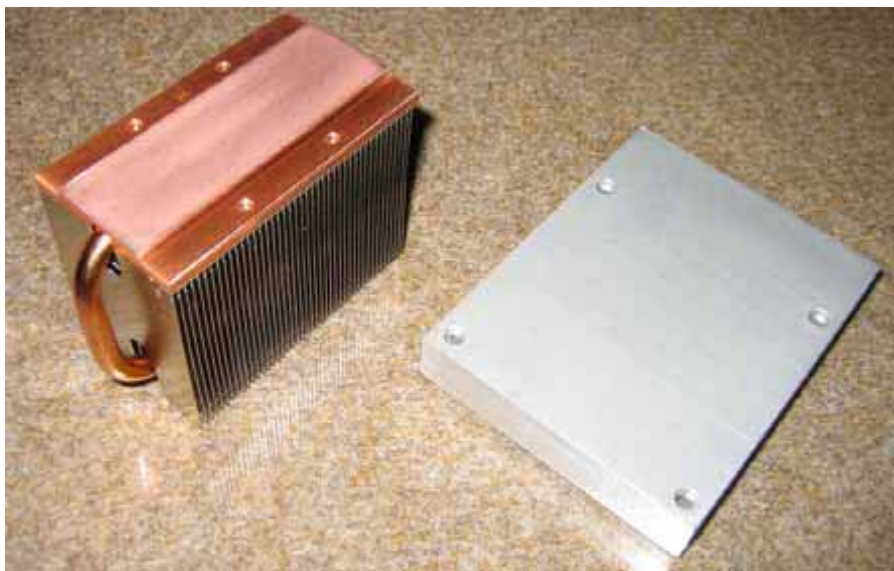
The following picture shows the finished result. Hard to capture on the camera, but they are smoother than they used to be before lapping.

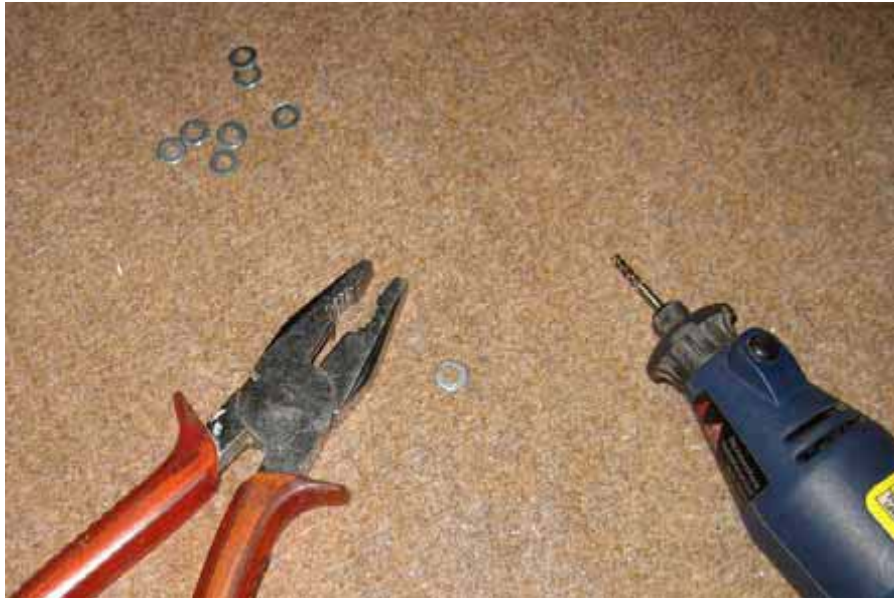
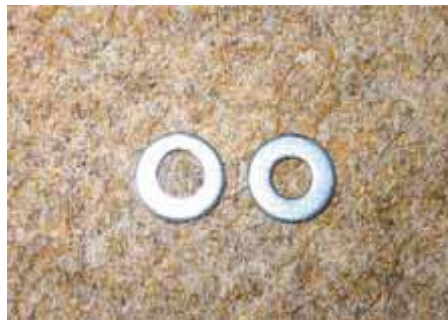
My 5/32" machine washers were too slightly small for the M5 bolt to go through. I had to use a rotary tool (dremmel clone) to cut away a bit to make the inner hole slightly larger.

This shows the before and after shot of one of the washers.

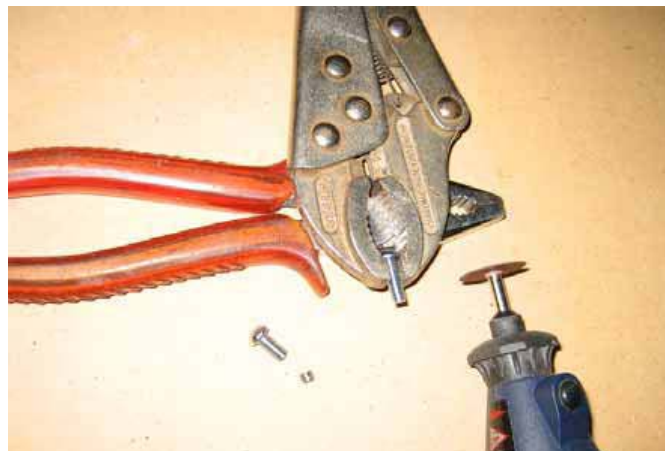
My 15mm bolts were too long. I cut them down to approx 10mm. The only 10mm bolts I could find had a large head on them, and they wouldn't fit properly under the Xbox motherboard. I simply cut the 15mm bolts using a cut-off wheel attachment.

This photo shows the bolts after I had cut them to size, with one 15mm thrown in for comparison.

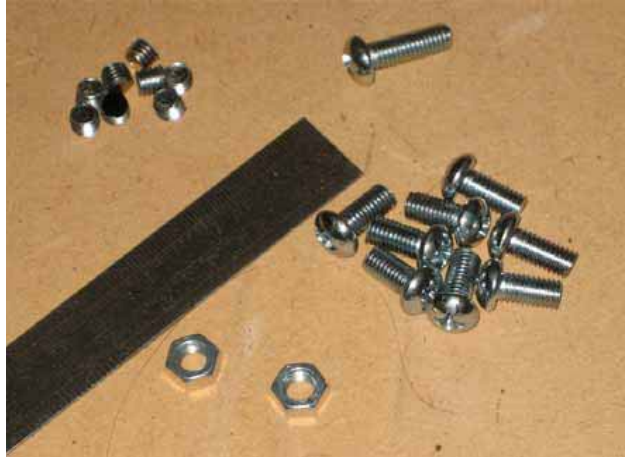
I couldn't find any nylon or fibre washers (use them if you can find them), so I had to improvise a bit. I used electrical tape on one side of the washer to insulate the washer from tracks on the motherboard.

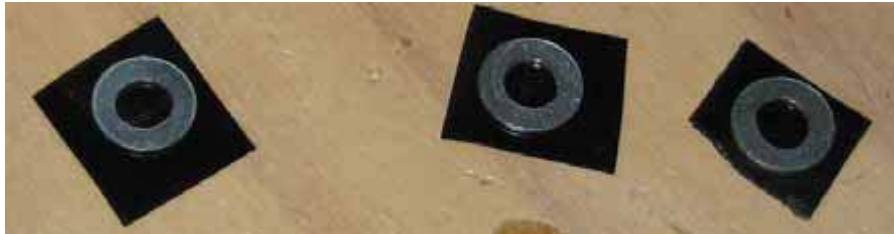
I cut a hole in the middle of the tape, and fed the bolt through, so that the exposed side of the washer was on the same side as the bolt head.

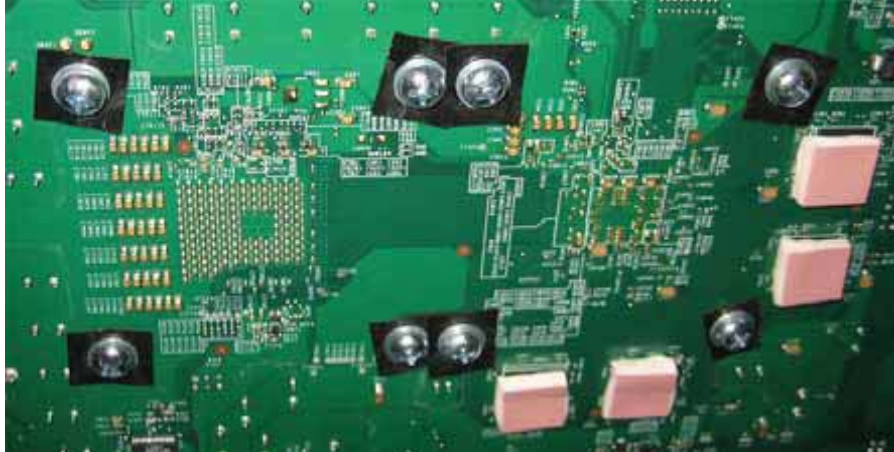
This is what the board looked like from underneath

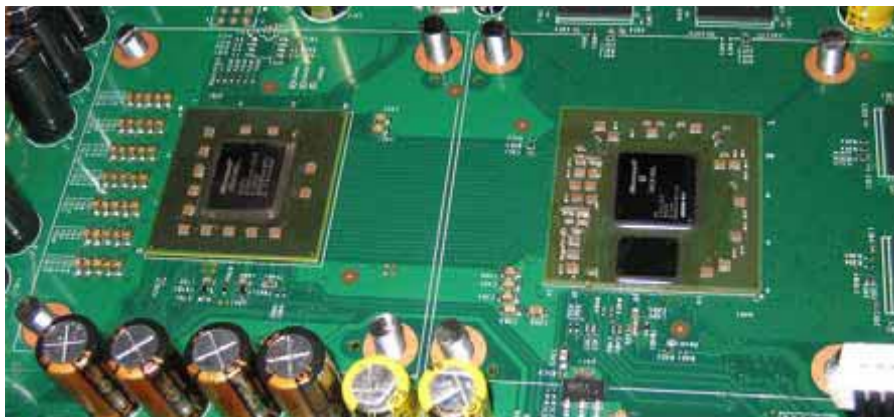
This is what the board looked like from above

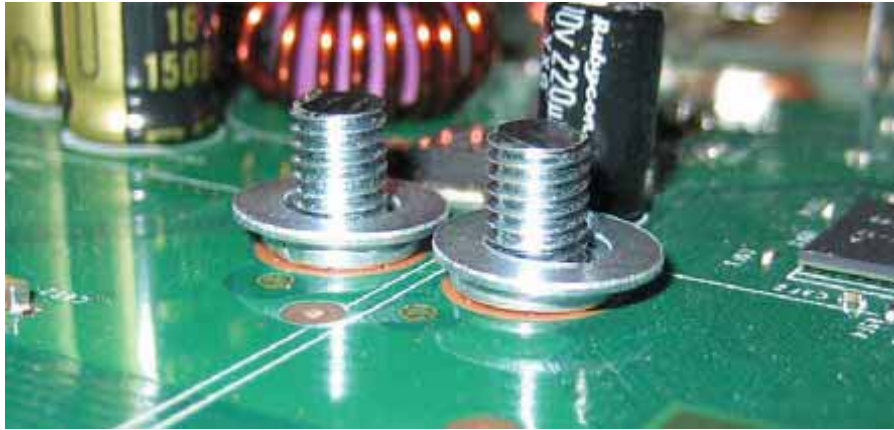
I used the 3/16" machine washers on top of the spring washers, as there wasn't any electrical parts they would touch, so even though they are slightly too big, they worked fine. These two washers ended up being the perfect height to support the heatsinks, and prevent too much pressure being applied on the board.

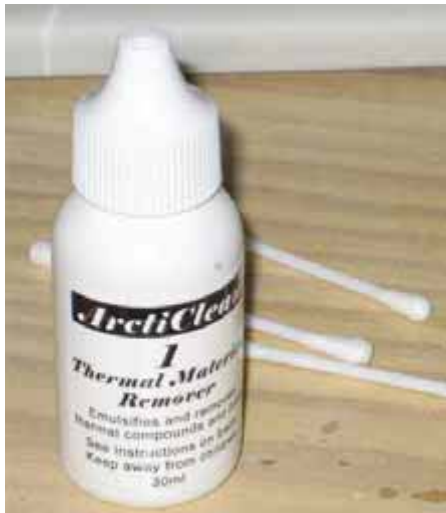
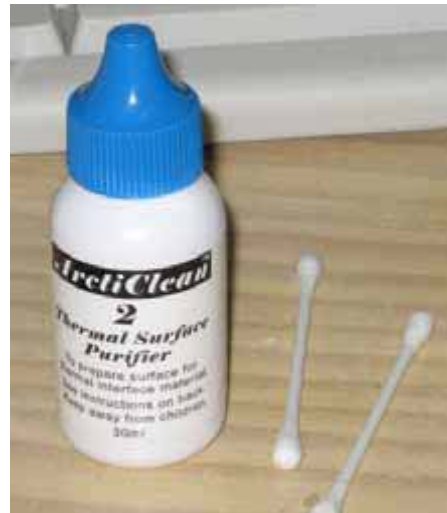
ArctiClean 1 and 2 work well for this part. I used both parts on the cpu, gpu, and heatsinks.

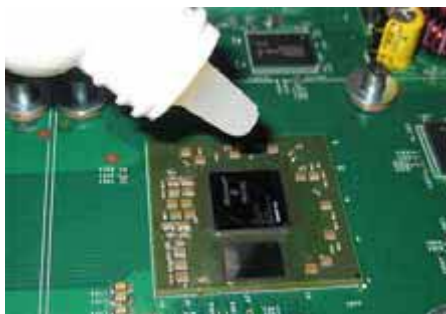
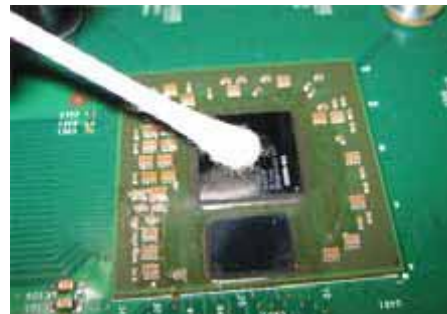
Use a toothpick or similar to remove any large chunks before using ArctiClean 1 to make it easier.

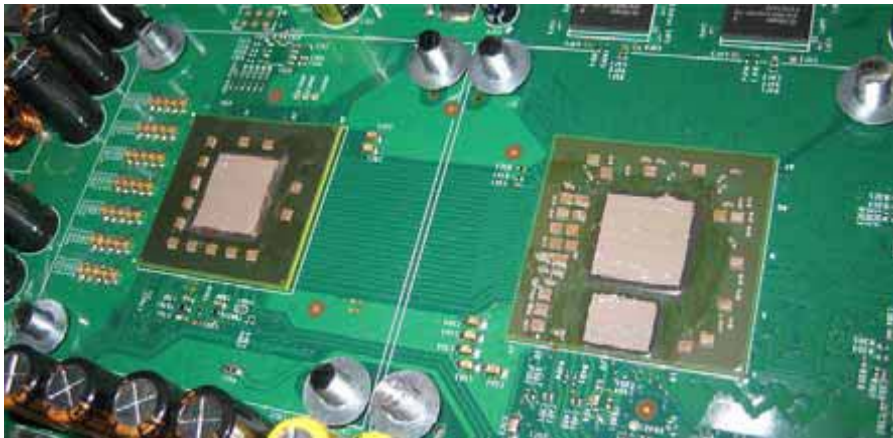
You have two options when applying Arctic Silver. You can use a rice sized blob, and let the heatsink spread it over the cpu, or spread the Arctic Silver over the cpu die evenly using a razor blade or other flat device. I went for the latter option, as I thought it might have been hard to get the heatsink to go straight down onto the cpu perfectly, due to the bolts getting in the way.

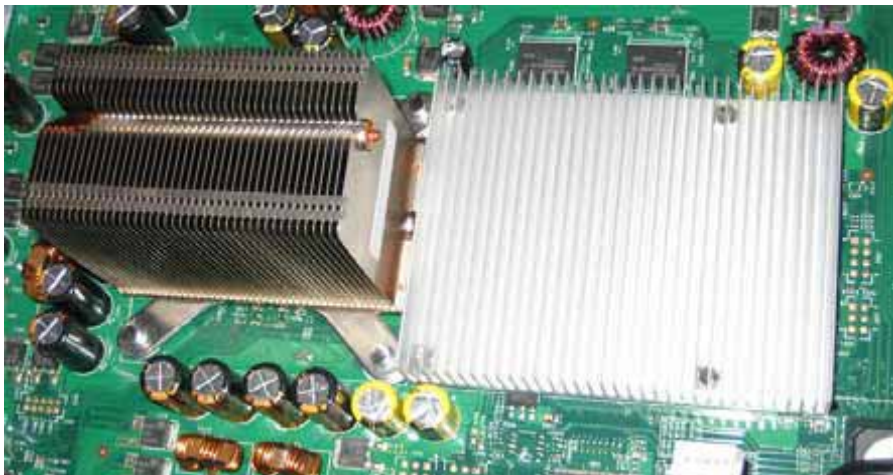
Lower the heatsinks down onto the bolts, align, and start screwing the bolts into the heatsinks. The M5 bolts should be a perfect fit for the original thread in both the heatsinks.

Don't over tighten any one bolt straight away. You need to allow even pressure on all 4 corners of each heatsink. Turn the screw's similar to a car tire, alternating the bolts you turn in a sort of star type pattern to apply even pressure on the cpu/gpu. Turn each bolt a little bit, and then move to the next.

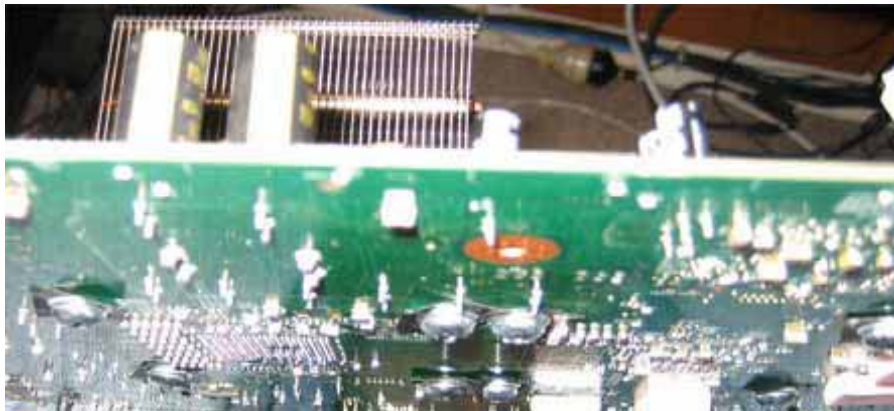
Seat the Xbox 360 motherboard back in the RF shield casing. Connect the power/led module to the front so we can turn it on, and see the LED's. Don't connect any fan's at this stage.

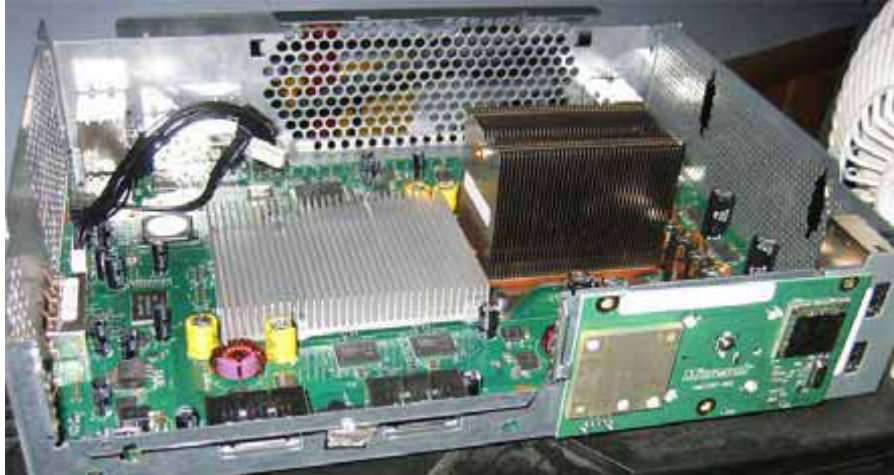
After the Xbox has cooled off, reattach the fans, put on the white air ducting, and give it a test.

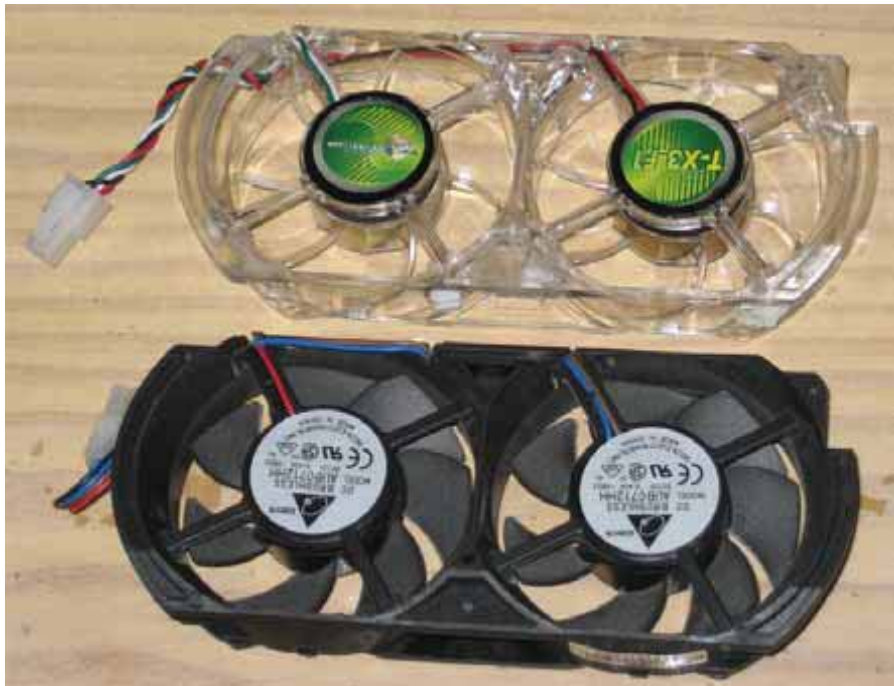
Any cooling mods that you can do will be beneficial. I added a set of Talismoon Whisper fans, replacing the original ones. They are meant to flow 50% more air or something around that figure. I may cut the mesh grill at the back to allow more air to flow through at a later date (both metal and plastic parts).
